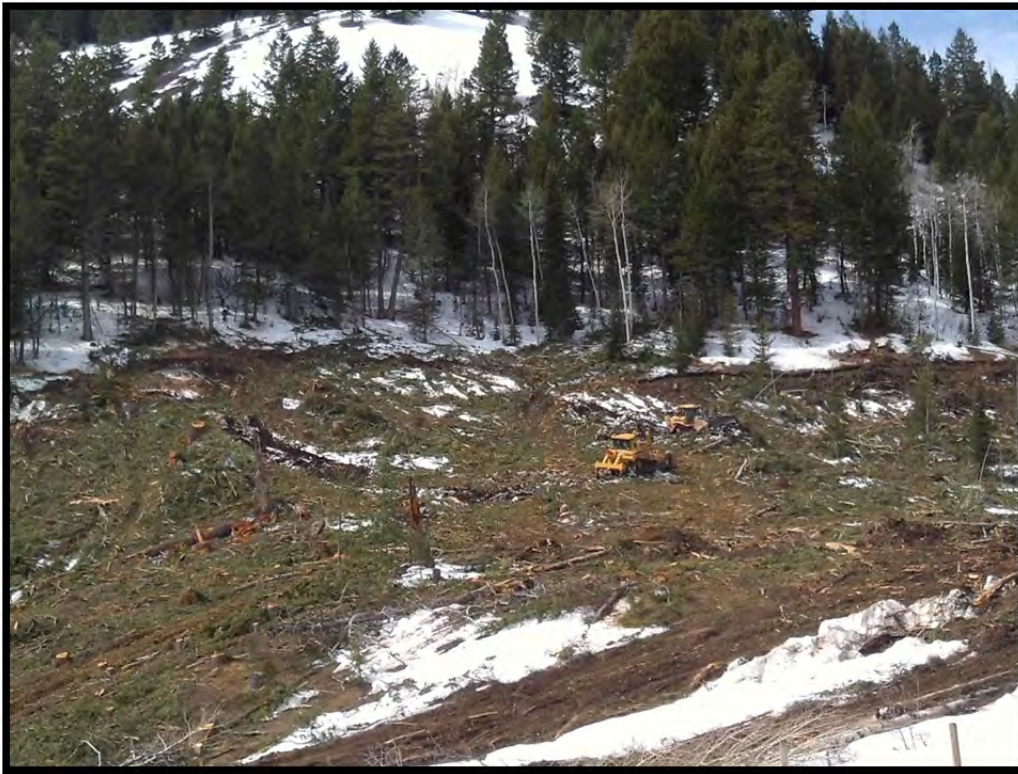
Photo 1: Clearing and grubbing the Dinwoody Borrow Area (3/16/2015).

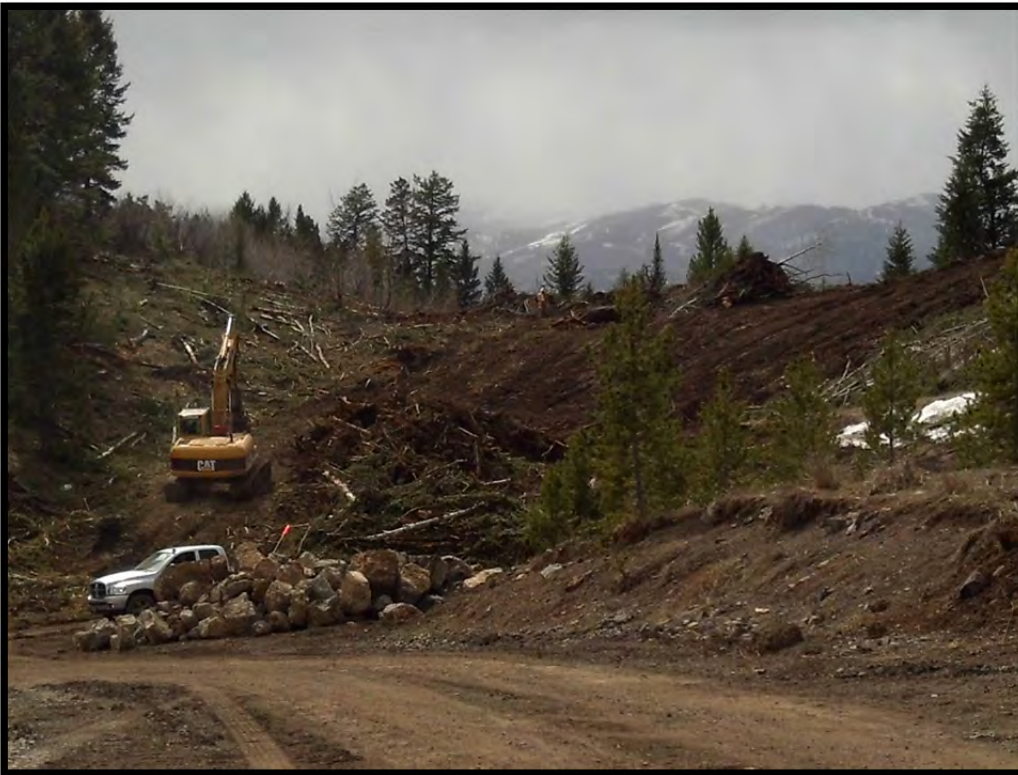
Photo 2: Clearing and grubbing the Dinwoody Borrow Area (3/31/2015).

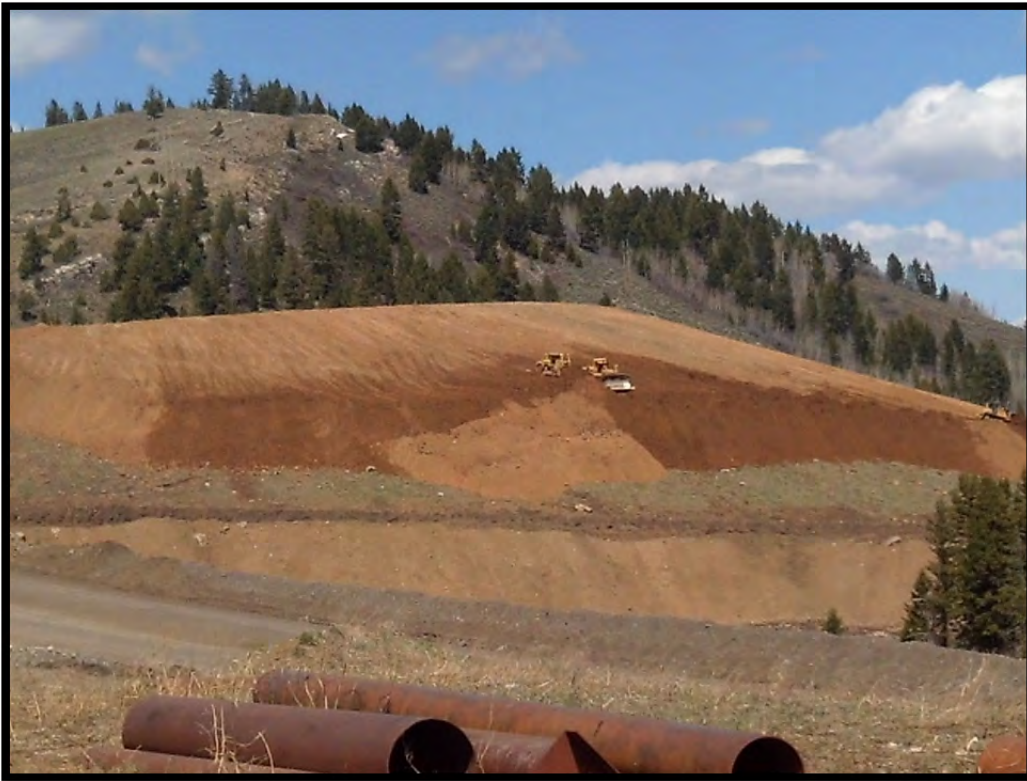
Photo 3: Spreading chert cover material on the east side of Pole Canyon ODA (4/20/2015).

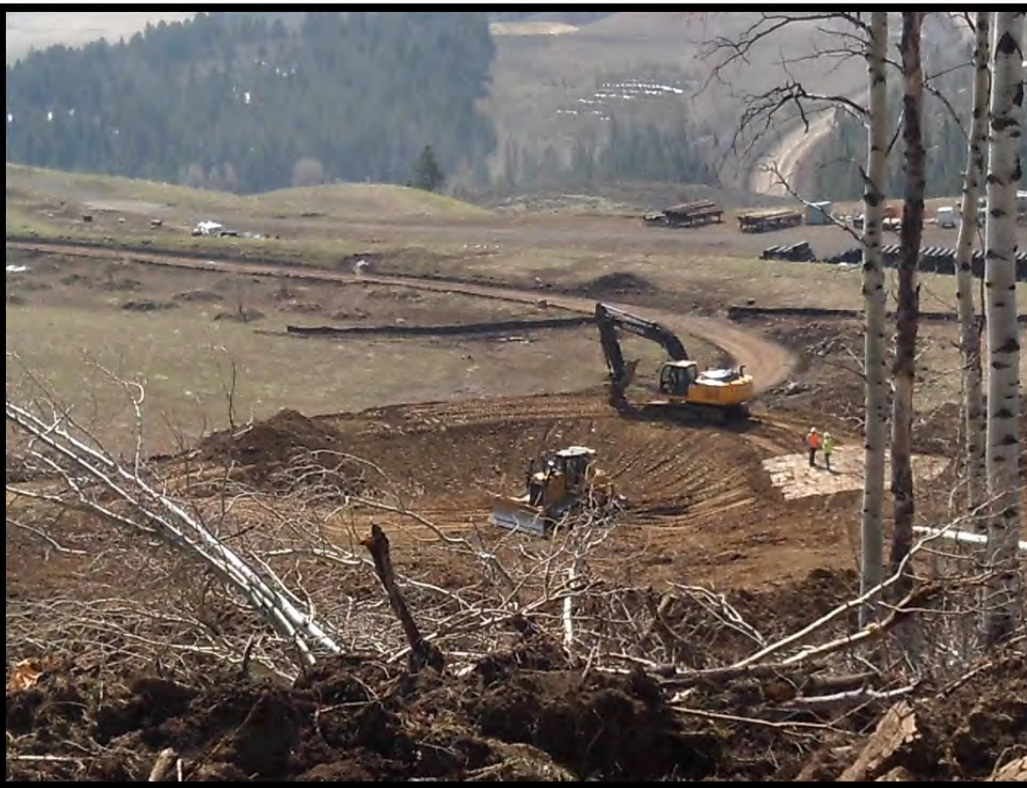
Photo 4: Construction of the South Sedimentation Basin at the Dinwoody Borrow Area (4/21/2015).

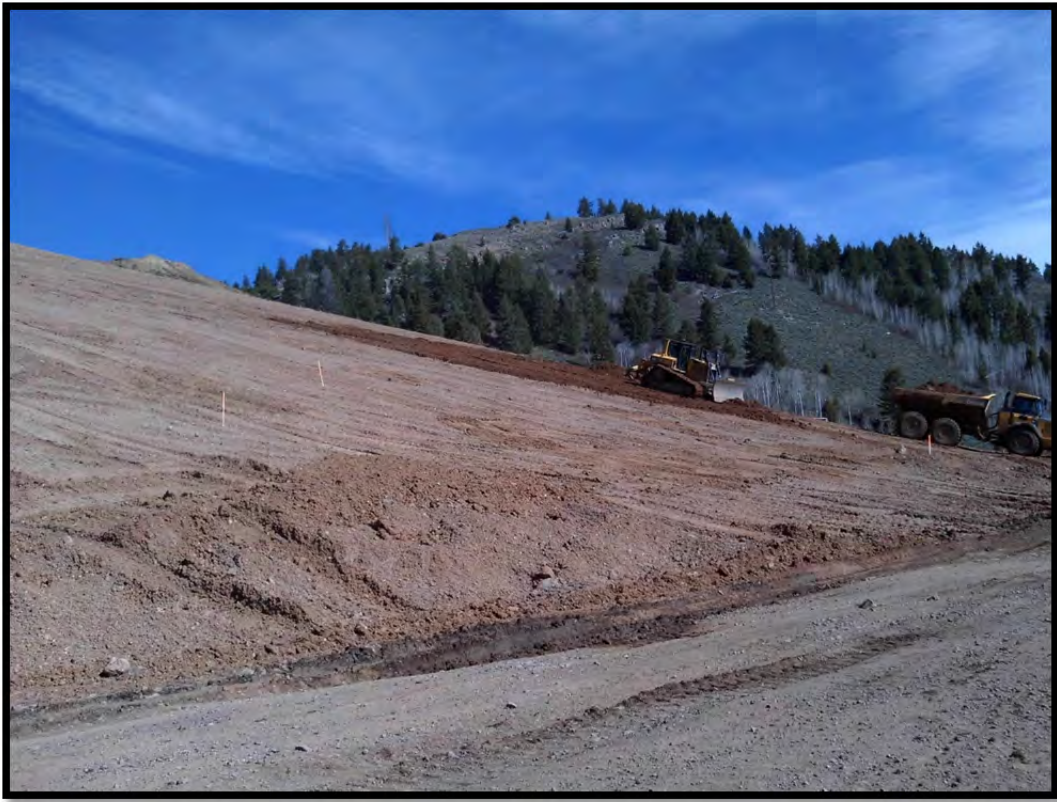
Photo 5: Spreading chert cover material on the east side of Pole Canyon ODA (4/29/2015).

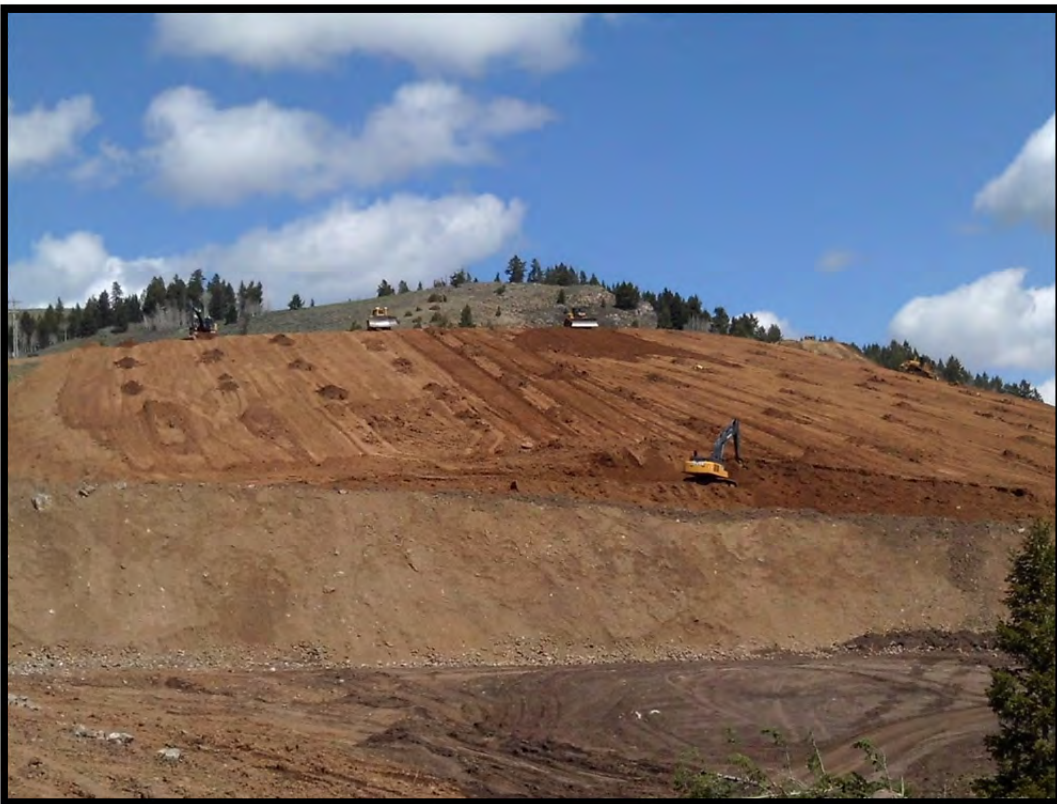
Photo 6: Checking chert layer thickness by potholing (4/30/2015).

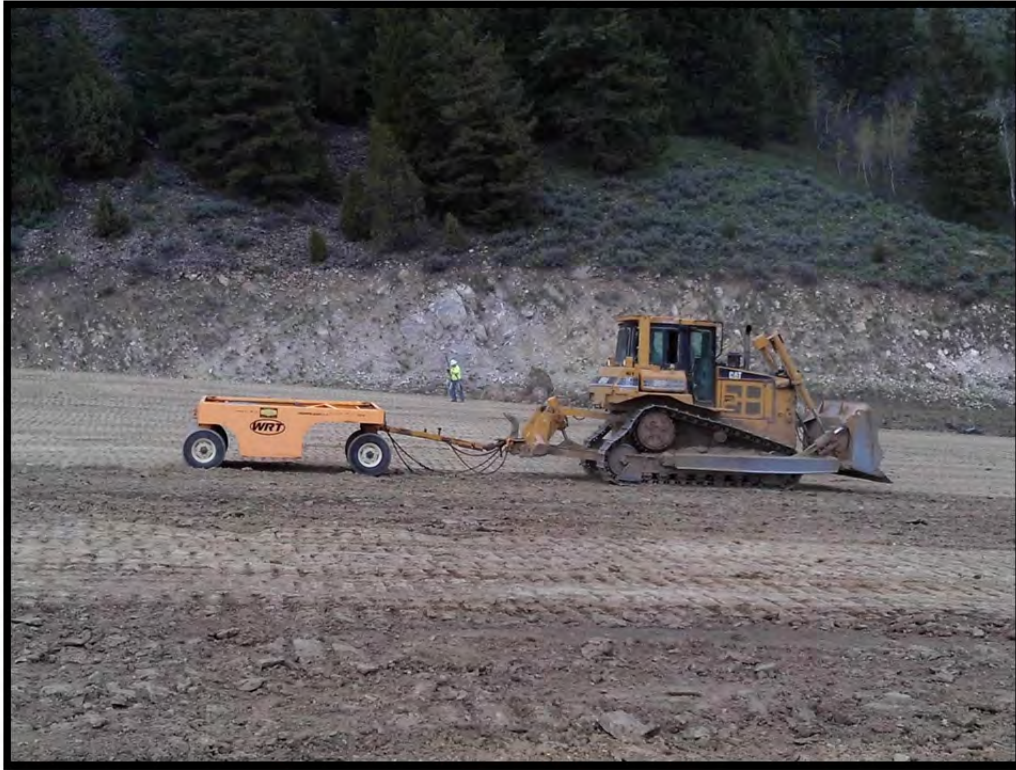
Photo 7: Rubber-tired compactor used to compact initial one-foot layer of Dinwoody cover material (5/6/2015).

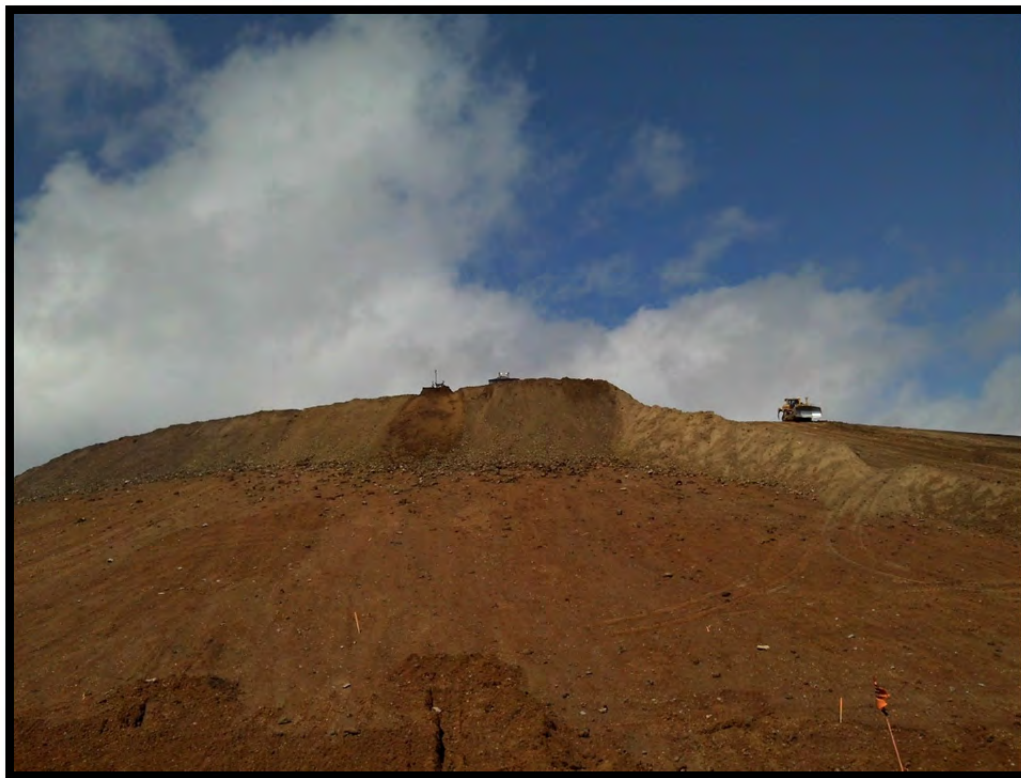
Photo 8: Spreading of Dinwoody material over chert layer, Pole Canyon ODA east side (5/6/2015).

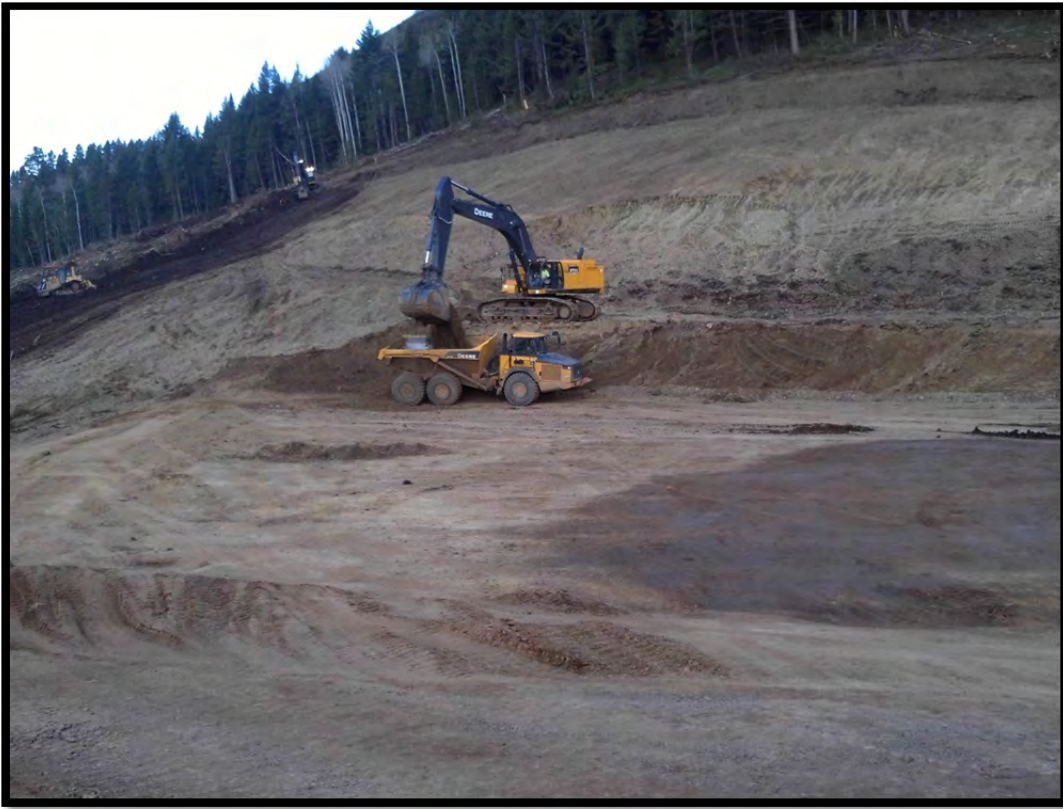
Photo 9: Removal of Dinwoody material from the Dinwoody Borrow Area (5/12/2015).

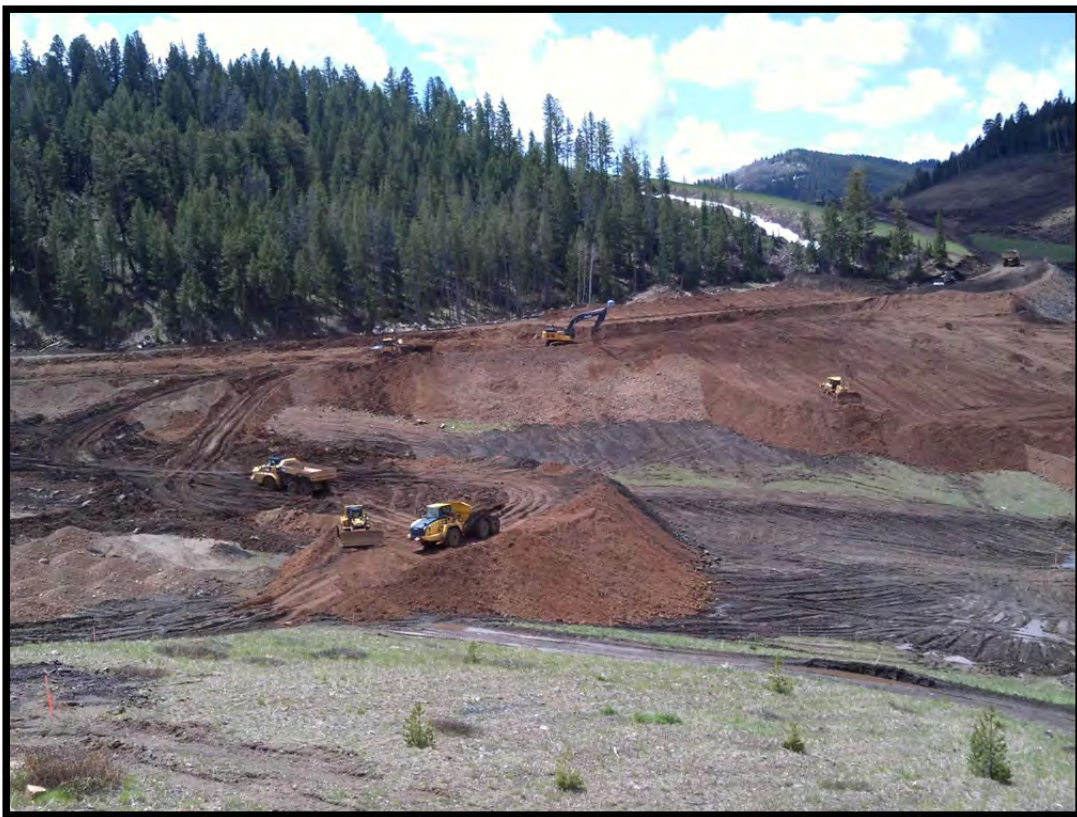
Photo 10: Spreading chert cover material on the west side of Pole Canyon ODA (5/21/2015).

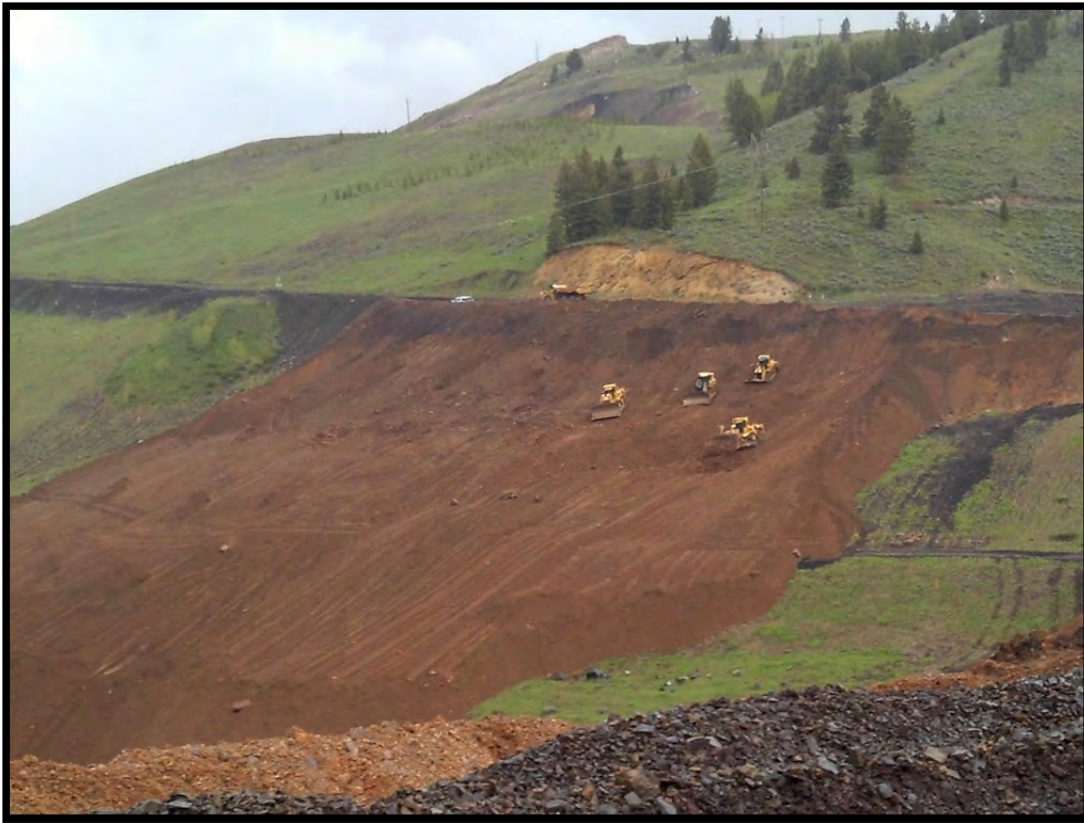
Photo 11: Spreading chert cover material on the west side of Pole Canyon ODA (5/27/2015).

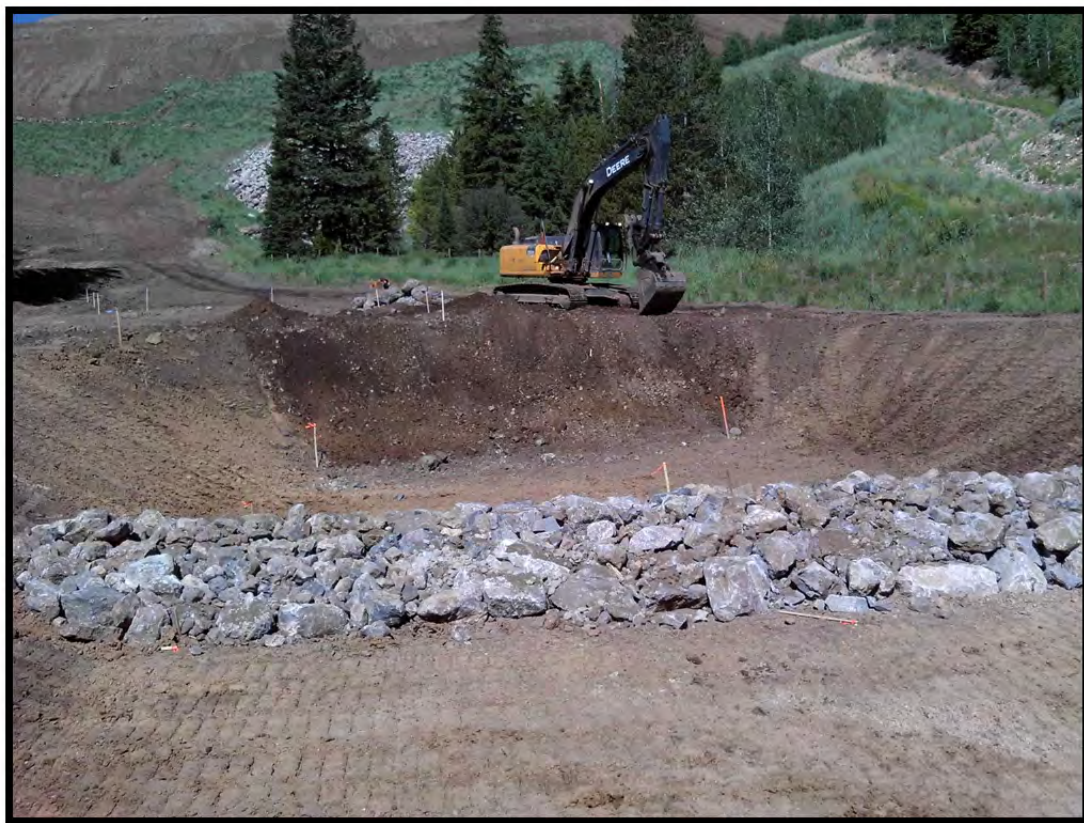
Photo 12: Construction of East Sedimentation Basin, near the east toe of Pole Canyon ODA (6/26/2015).

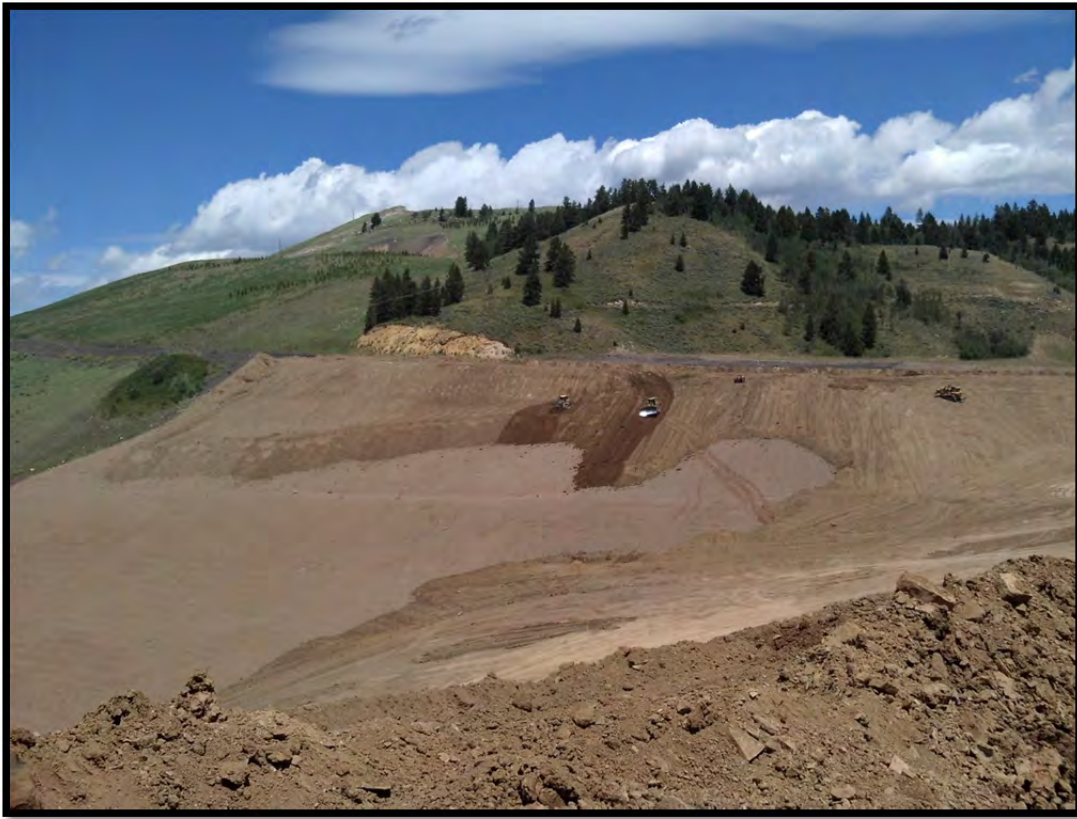
Photo 13: Spreading of Dinwoody material over chert layer, Pole Canyon ODA west side (7/17/2015).

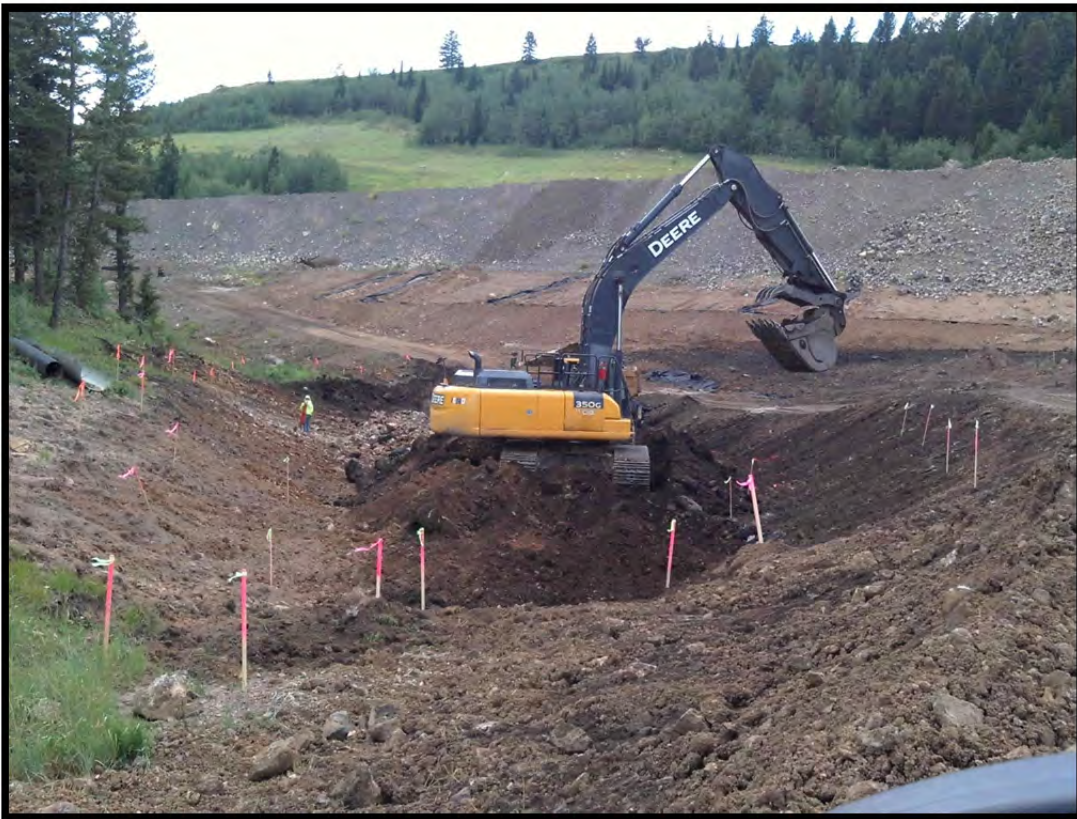
Photo 14: Construction of South Central Sedimentation Basin (7/23/2015).

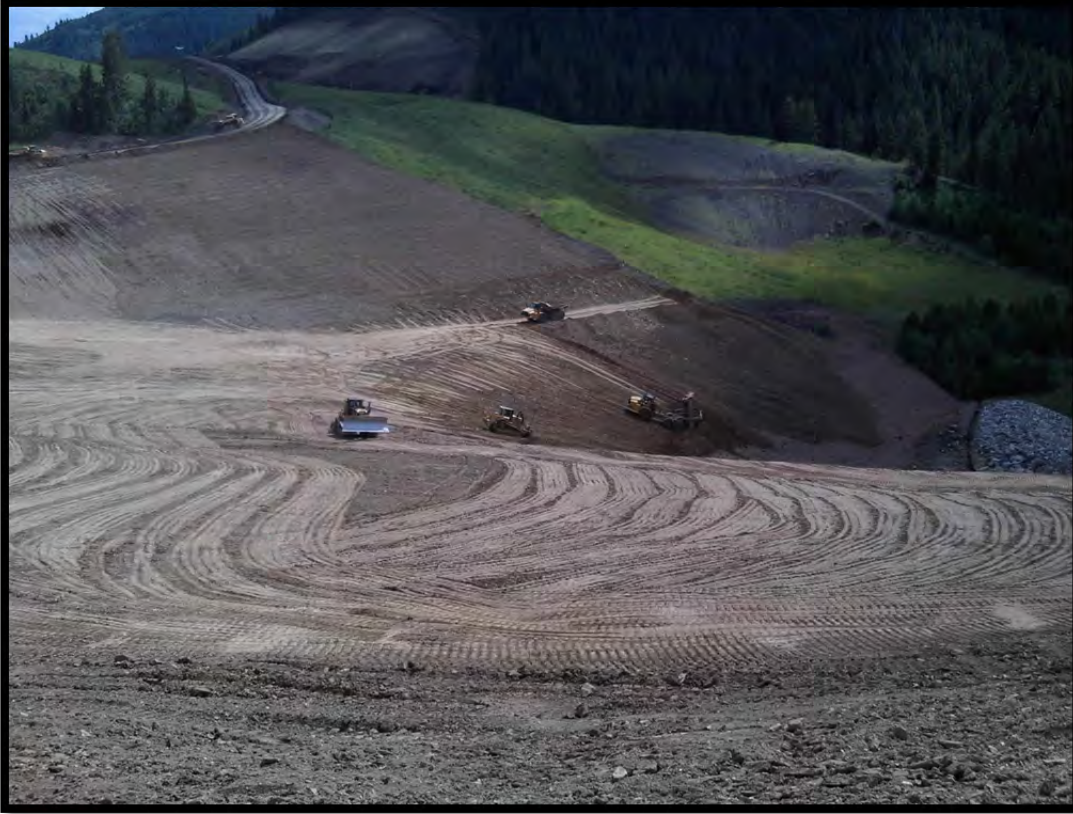
Photo 15: Spreading of Dinwoody material over chert layer, Pole Canyon ODA west side (7/23/2015).

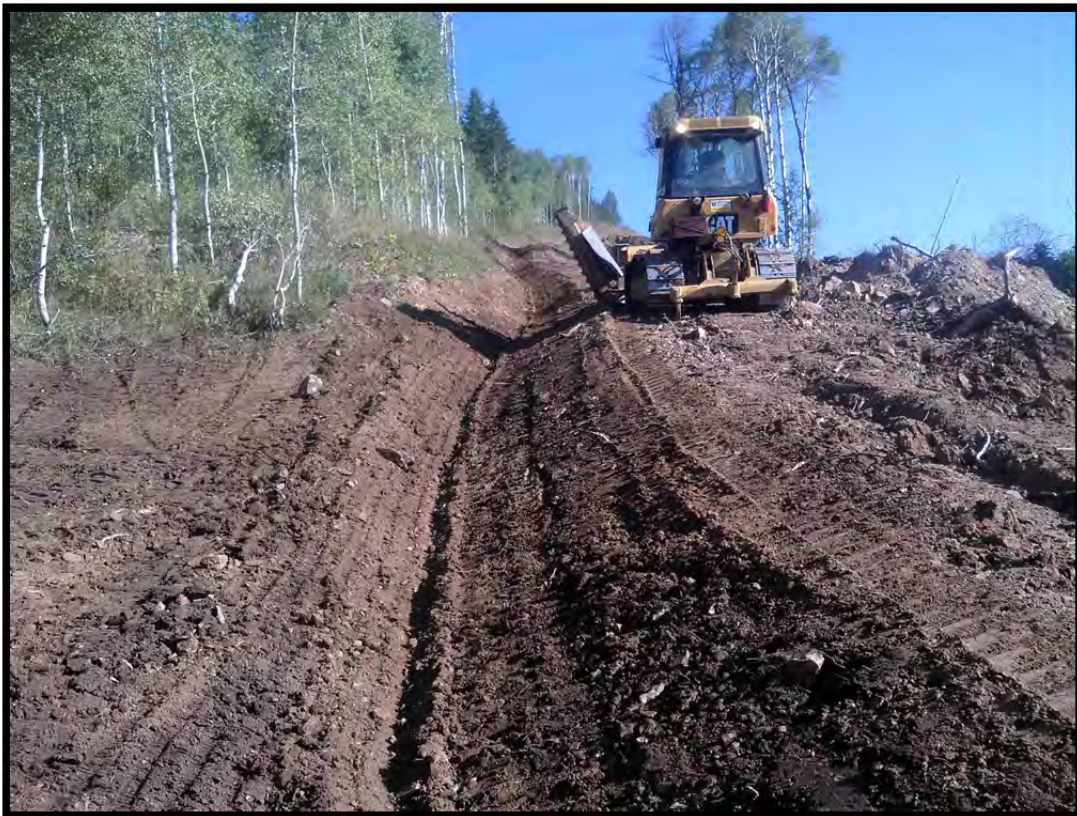
Photo 16: Construction of run-on control ditch, Dinwoody Borrow Area (8/27/2015).

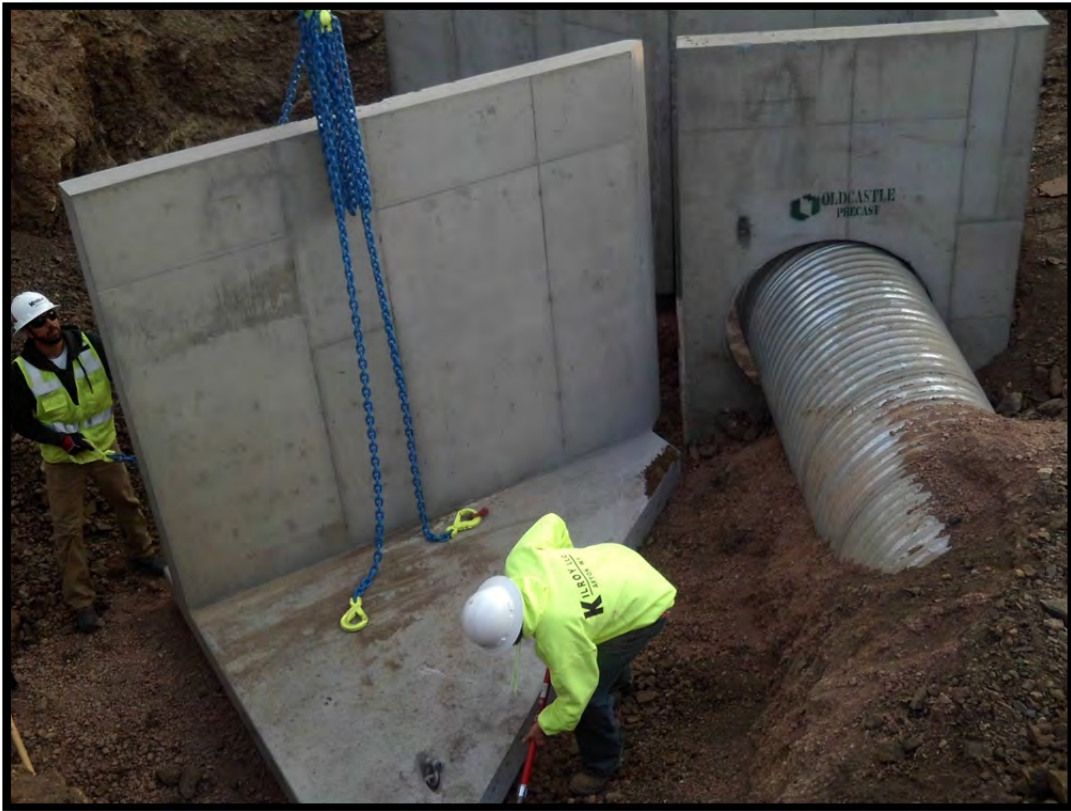
Photo 17: Installation of intake structure for A-Panel runoff ditch into 42-inch CMP under mine haul road (9/16/2015).

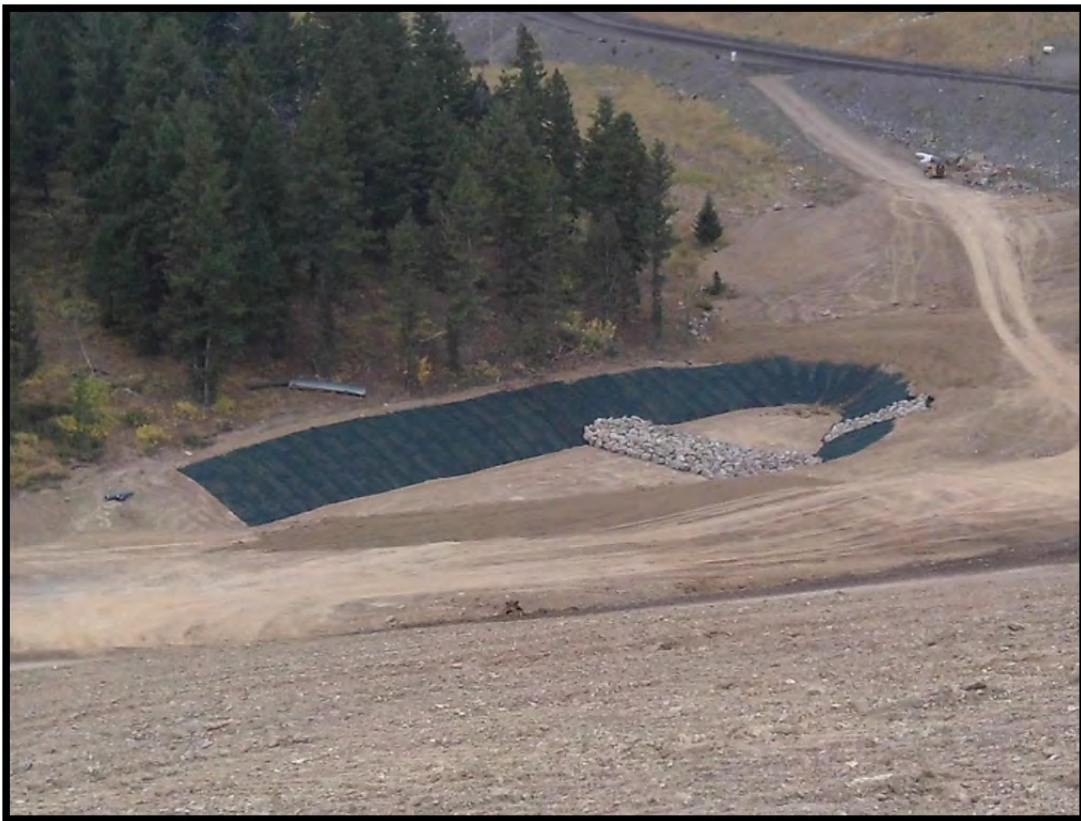
Photo 18: South Central Sedimentation showing TRM on side slopes and interior rock berm (9/16/2016).

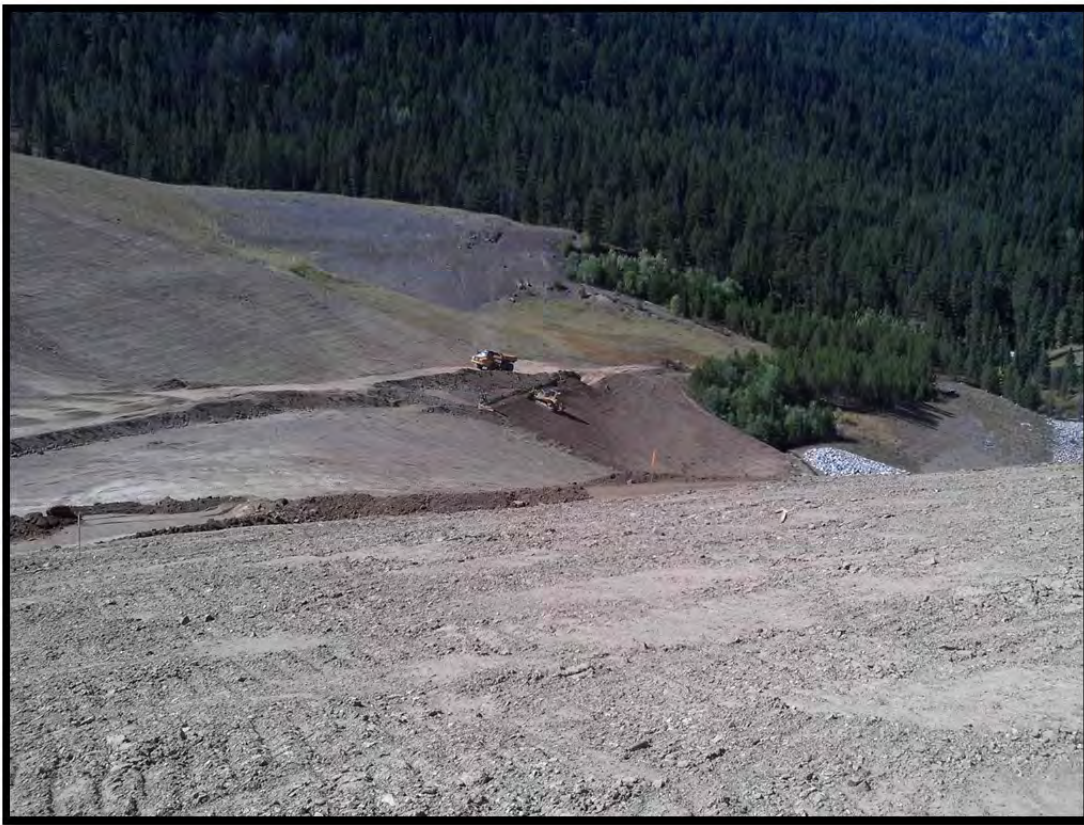
Photo 19: Construction of West-Side Ditch (9/16/2015).

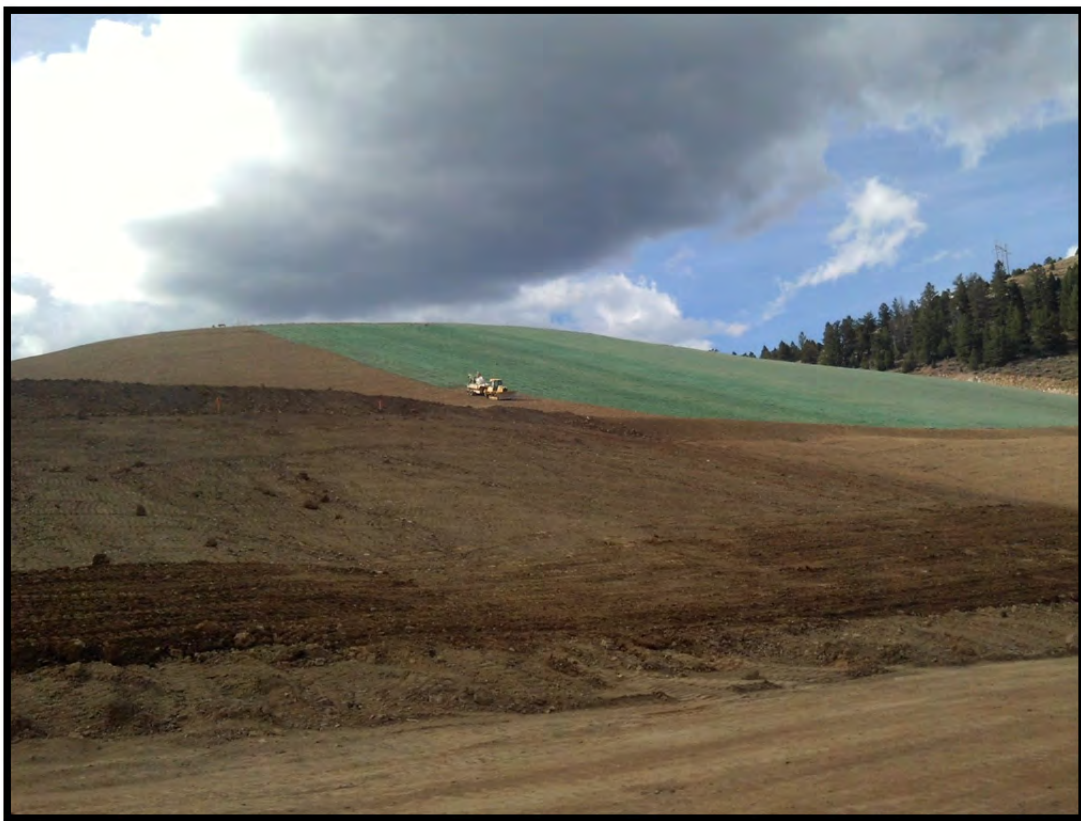
Photo 20: Hydromulch application on Dinwoody cover, east side of Pole Canyon ODA (10/6/2015).

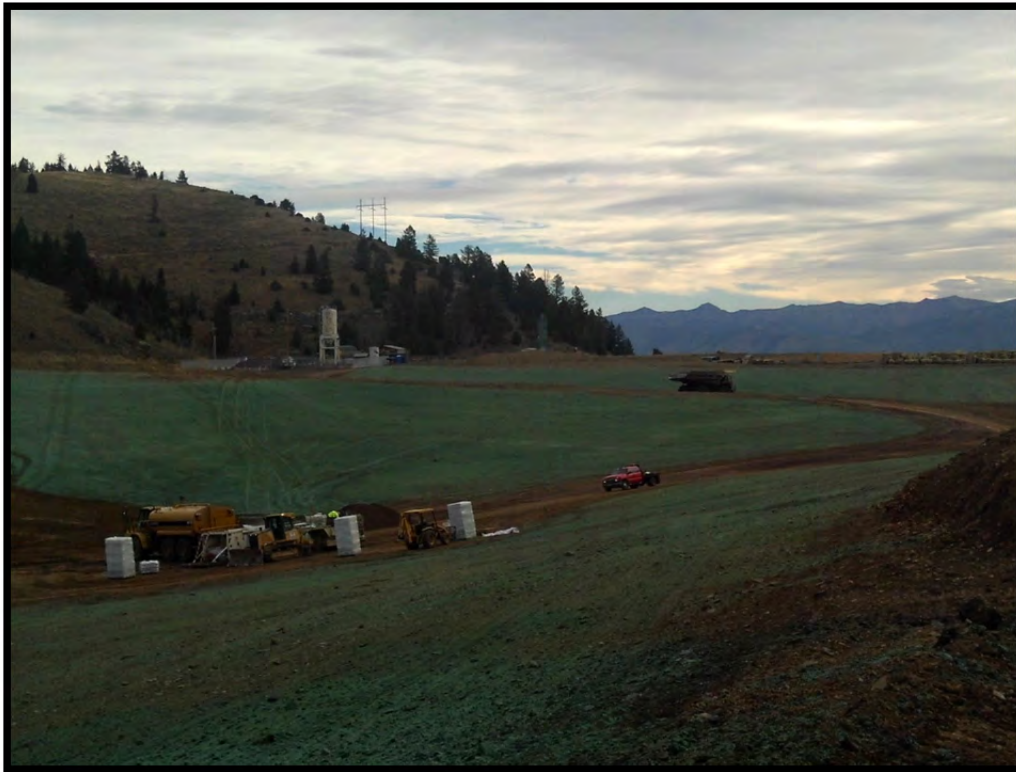
Photo 21: Hydromulch application on Dinwoody cover, west side of Pole Canyon ODA. Note relocated Blast Compound at left center (10/7/2015).

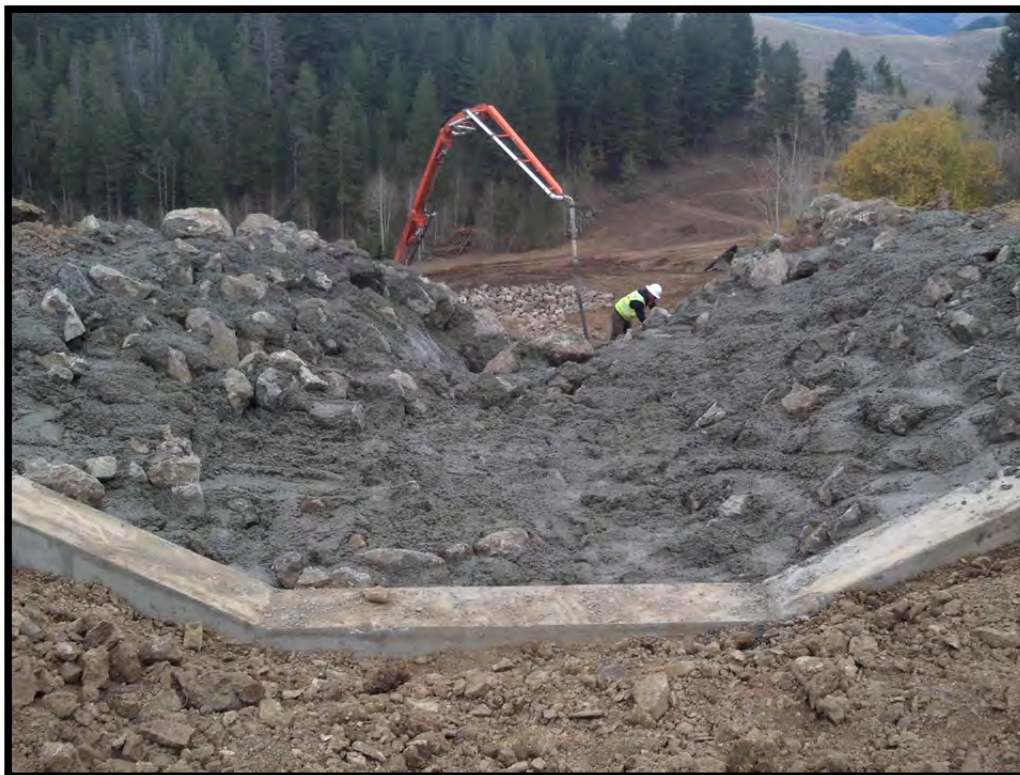
Photo 22: Grouting riprap in the South Central Chute, upstream of Saddle Basin (10/22/2015).

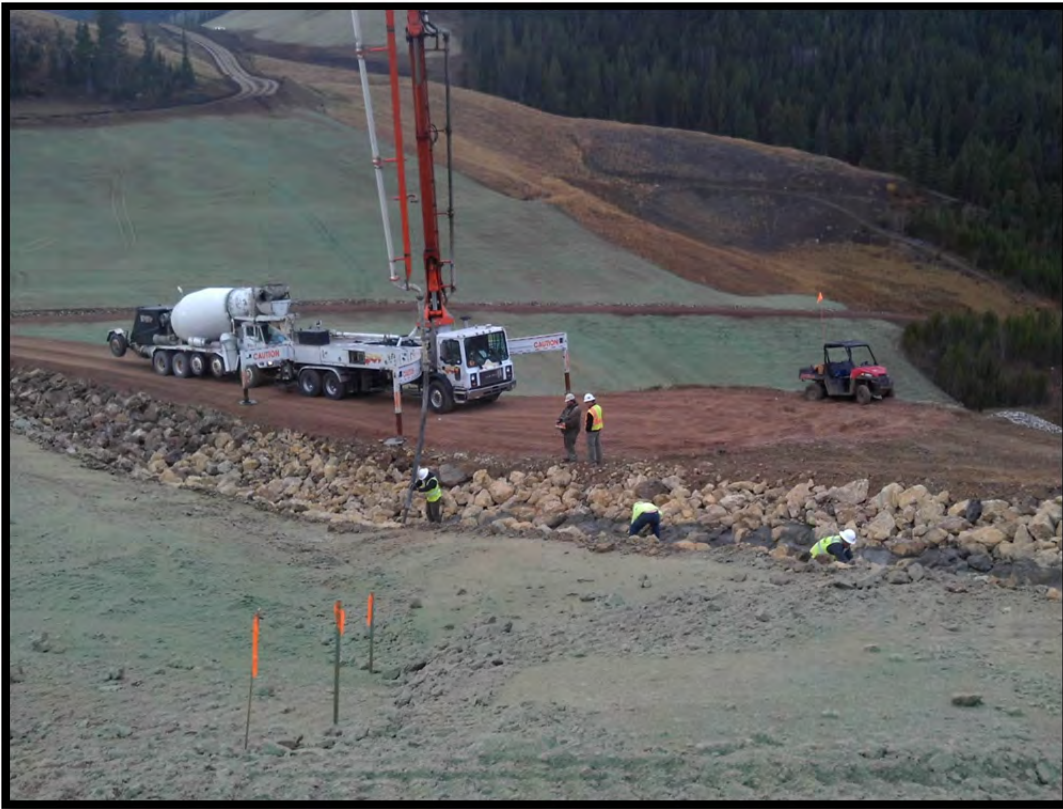
Photo 23: Grouting riprap in the West Side Runoff Ditch (10/22/2015).

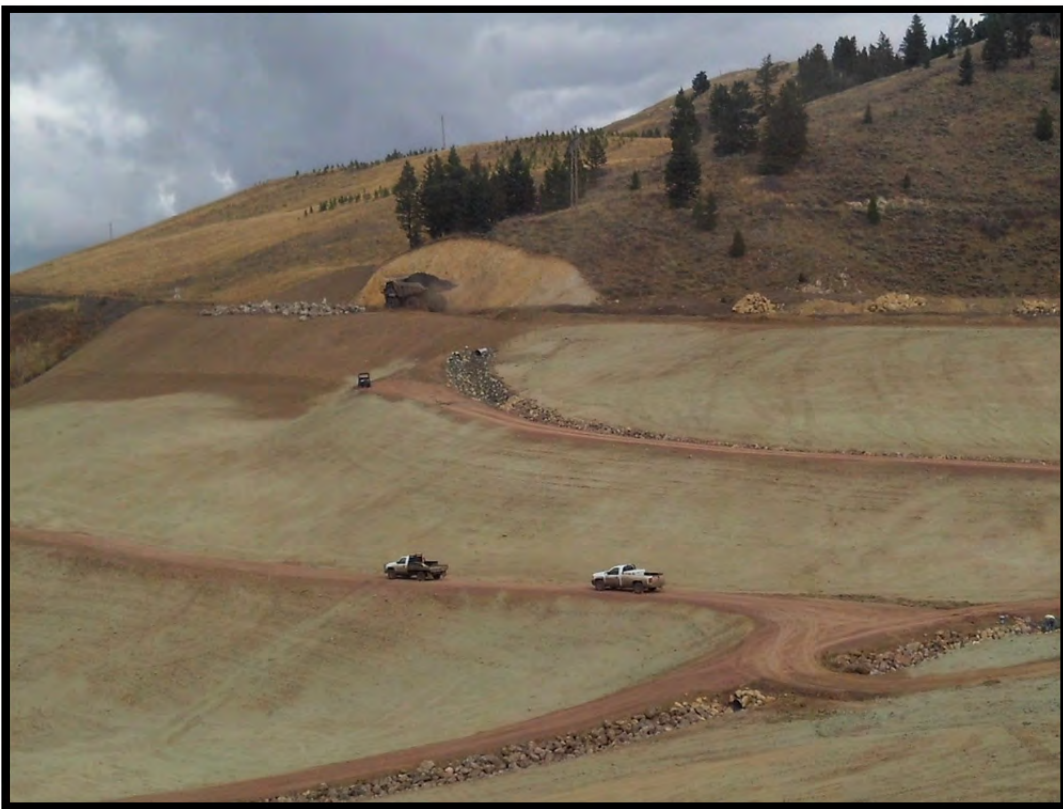
Photo 24: West slope of Pole Canyon ODA with completed cover and hydromulch (10/22/2015).

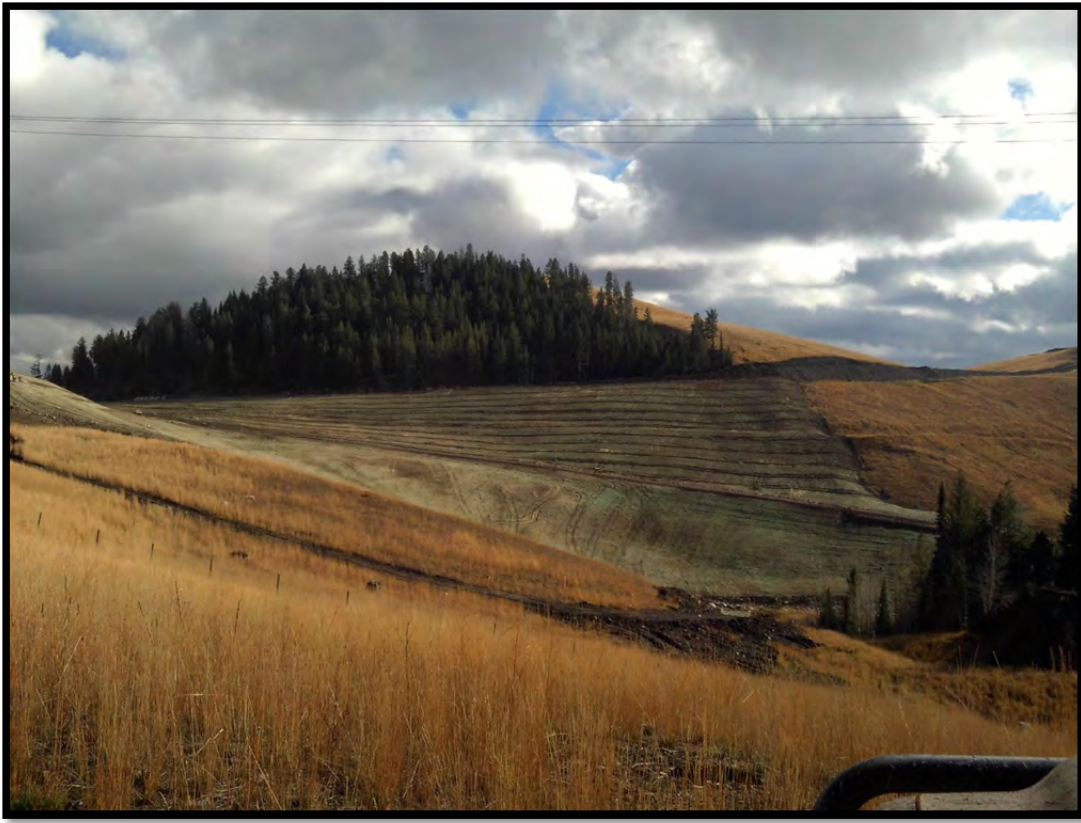
Photo 25: West slope of Pole Canyon ODA with hydromulch and straw wattles (11/4/2015).
